Inspection Report

Minerals Regulatory Program

Mine Name: Milla' Martinique
Operator Name: Martinique Mining

Permit number: S0170046
Inspection Date: May 12, 2008
Time: 1:00-1:20 PM

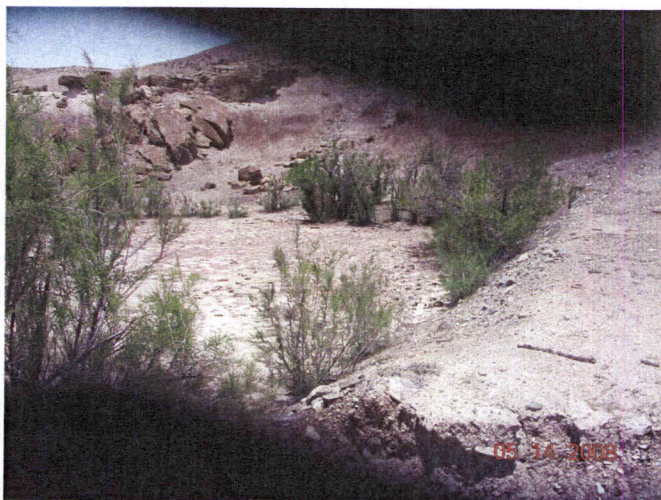
On the north side of the site is a series of small impoundments, and the dams have breached (Photo 1). (Unfortunately my lens cover did not fully open, and I was not aware of this until getting the pictures off the camera.) Vegetation around these ponds is mostly greasewood. On the southeast side is a larger impoundment with a lot of tamarisk around the edges (Photo 2), but as far as I can determine, this pond is not part of the operator's responsibility (see discussion under conclusions and recommendations below).

Photo 1. This is a small pond on the north side of the site where the dam has breached.

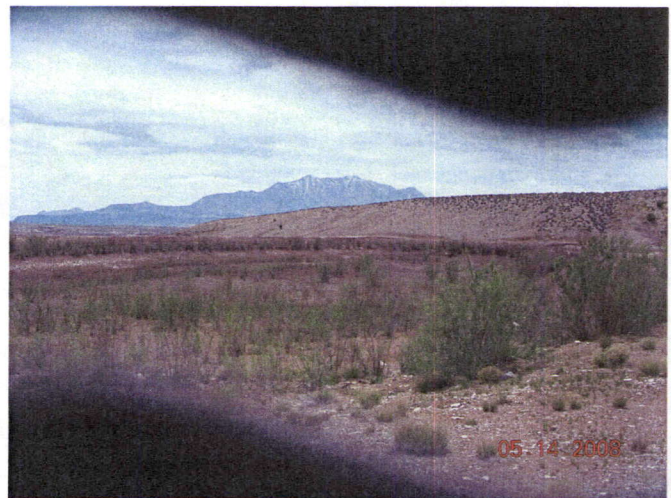
According to the NOI, tailings would be stored in a small pond and cleaned up and stacked for testing. This small pond is not the same as the larger pond, and I was unable to see any sign of the smaller pond. Buzz Rakow of the BLM said the BLM has not considered the pond as part of Milla' Martinique.

Photo 2. This pond is adjacent to the mill site but is not part of the operator's responsibility.

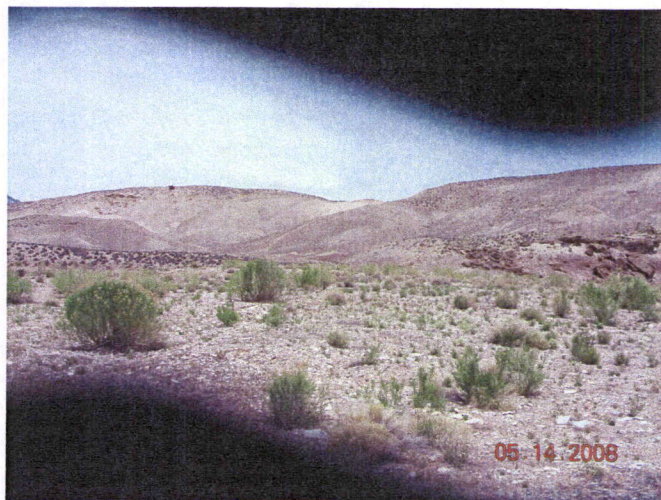
Vegetation in the reclaimed area also varies widely, but in this case it is more because of the degree of compaction of working areas. I estimated cover to be 14.7 percent. Most of the vegetation is rabbitbrush, and there are a lot of rabbitbrush seedlings.

Photo 3. This picture and Photos 4 through 6 show the reclaimed area and some of the adjacent undisturbed areas.
